## Metro Fence removes the need to saw into pavement for a non-contact solution on a barrier arm

BEA Customer - Metro Fence Company, Inc.

BEA Product(s) - SUPERSCAN-T INDUSTRIAL - active infrared presence sensor

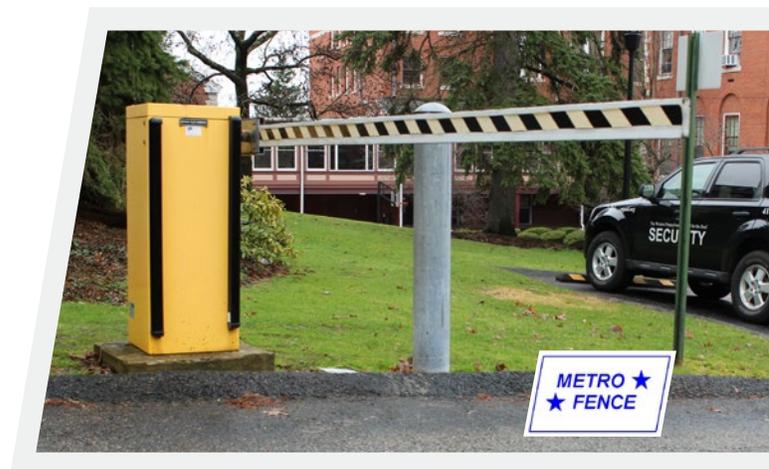
Instead of traditional photo beams, Metro Fence created barrier arm safety and free exit capability by daisy-chaining two SUPERSCAN-T INDUSTRIAL sensors side-by-side. The inbound sensor contains two master modules wired in a series, which both must be tripped for activation of the barrier arm; while the outbound sensors serve as a safety reset. For even more protection, the SUPERSCAN-T INDUSTRIAL sensors offer infinite detection within their range of eight to 10 feet, meaning that if an object is detected, they will never time out.

Unlike the typical transmitter and reflective receiver configuration, SUPERSCAN-T INDUSTRIAL sensors utilize triangulation; permitting the sensor to detect objects without relying on the background. A benefit of this is that it is not necessary to cut into the pavement for photo beam wiring, saving time and money.

The final install uses a combination of master sensor modules for activation and safety, while providing directionality for free exit capabilities. Without any major maintenance issues, besides regularly cleaning the sensor lenses, all of the barrier arms have been functioning without interruptions for the past six years.
