100 ENTERPRISE DRIVE PITTSBURGH, PA 15275 PHONE: (412) 249-4100 FAX: (412) 249-4101 EMAIL: www.beasensors.com	
		<b>TITLE: BESAM CUP VER. 6.3,6.4 CONTROL WITH LO-21P PARALLAX II SYSTEM Q-DISCONNECT ON APPROACH SIDE</b>	
SIZE: <b>B</b>	DRAWN BY: KJG	REV BY: TUC	PART NO: 80.0193.02
SCALE: NONE	DATE: 02 DEC 2005	SHEET 1 OF 1

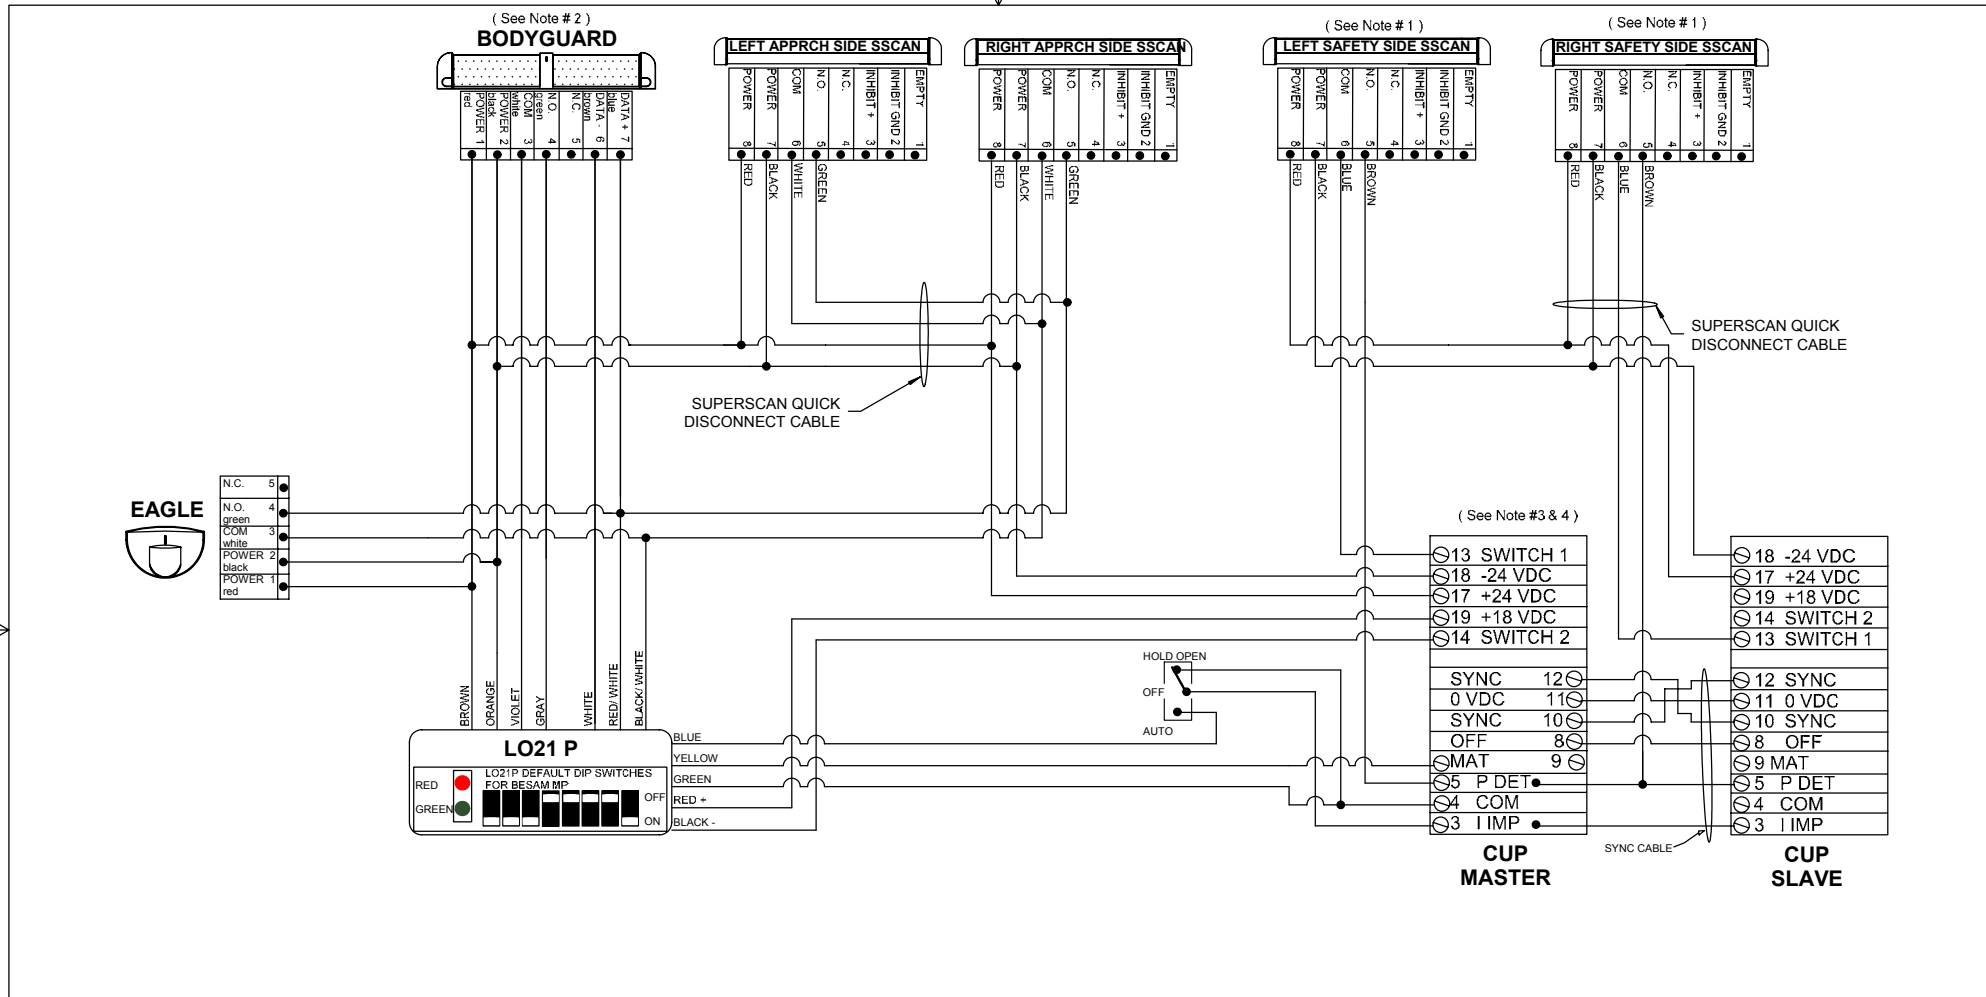
- NOTES: 1 ) INSERT SAFETY SIDE SUPERSCAN BLUE WIRE INTO PIN 6, BROWN WIRE INTO PIN 5, AND WHITE WIRE INTO PIN 1.  
 2 ) THE BODYGUARD RELAY OUTPUT FUNCTION MUST BE CHANGED TO #2.  
 3 ) DO NOT POWER ALL THE SENSORS FROM ONE CONTROL BOX.  
 4 ) ON BOTH CONTROLS SET PMD FUNCTIONS 20=a, 19=b, 18=00, 17=00, 14=a, 13=a, 12=3 DEGREES LESS THAN F10, 11= 65 DEGREES  
 5 ) INHIBITING THE SAFETY SIDE SUPERSCAN (F11) SHOULD OCCUR AT APPROX. 65-75 DEGREES.
