TITLE: LZR i30 W/ BR3 AND DELAYED WARNING LIGHT

SIZE:	DRAWN BY: WJR	REV BY:	PART NO: 80.0360.00
Α	SCALE:	DATE:	SHEET
	NONE	08012014	1 OF 1

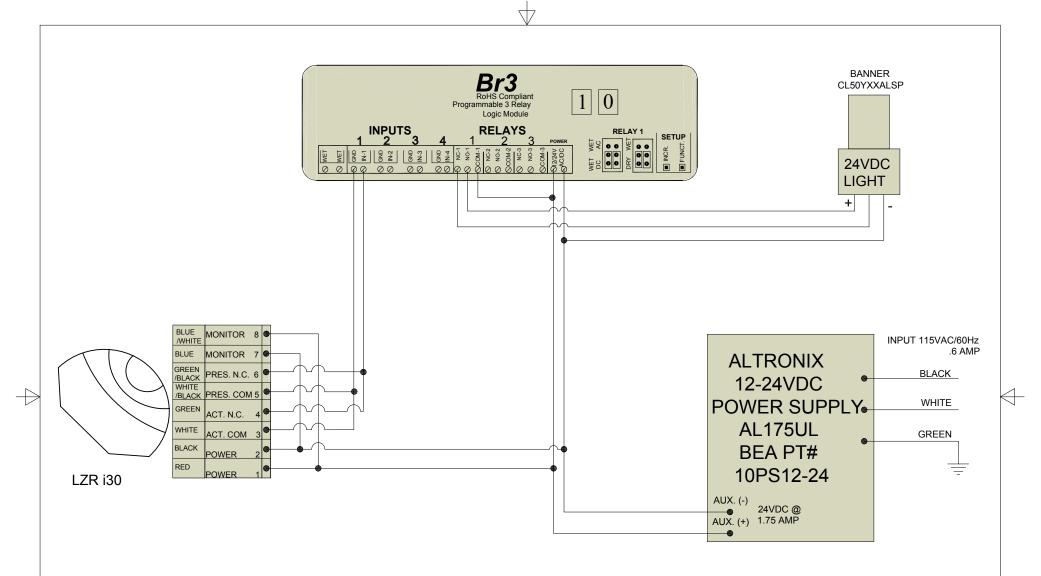
NOTES: 1) SET LZR i30 OUTPUT CONFIGURATION TO "2"

2) SET BR3 TO FUNCTION "10"

3) SET BR3 TIMER "H1" TO 10 SECONDS. THIS WILL BE THE TIME THAT SENSOR MUST BE IN DETECTION BEFORE LIGHT CHANGES!
