BEA
OPEN UP NEW HORIZONS
HALMA GROUP COMPANY

TITLE: BESAM CU-2 WITH EAGLE & APPR & SAFETY SS SCANS

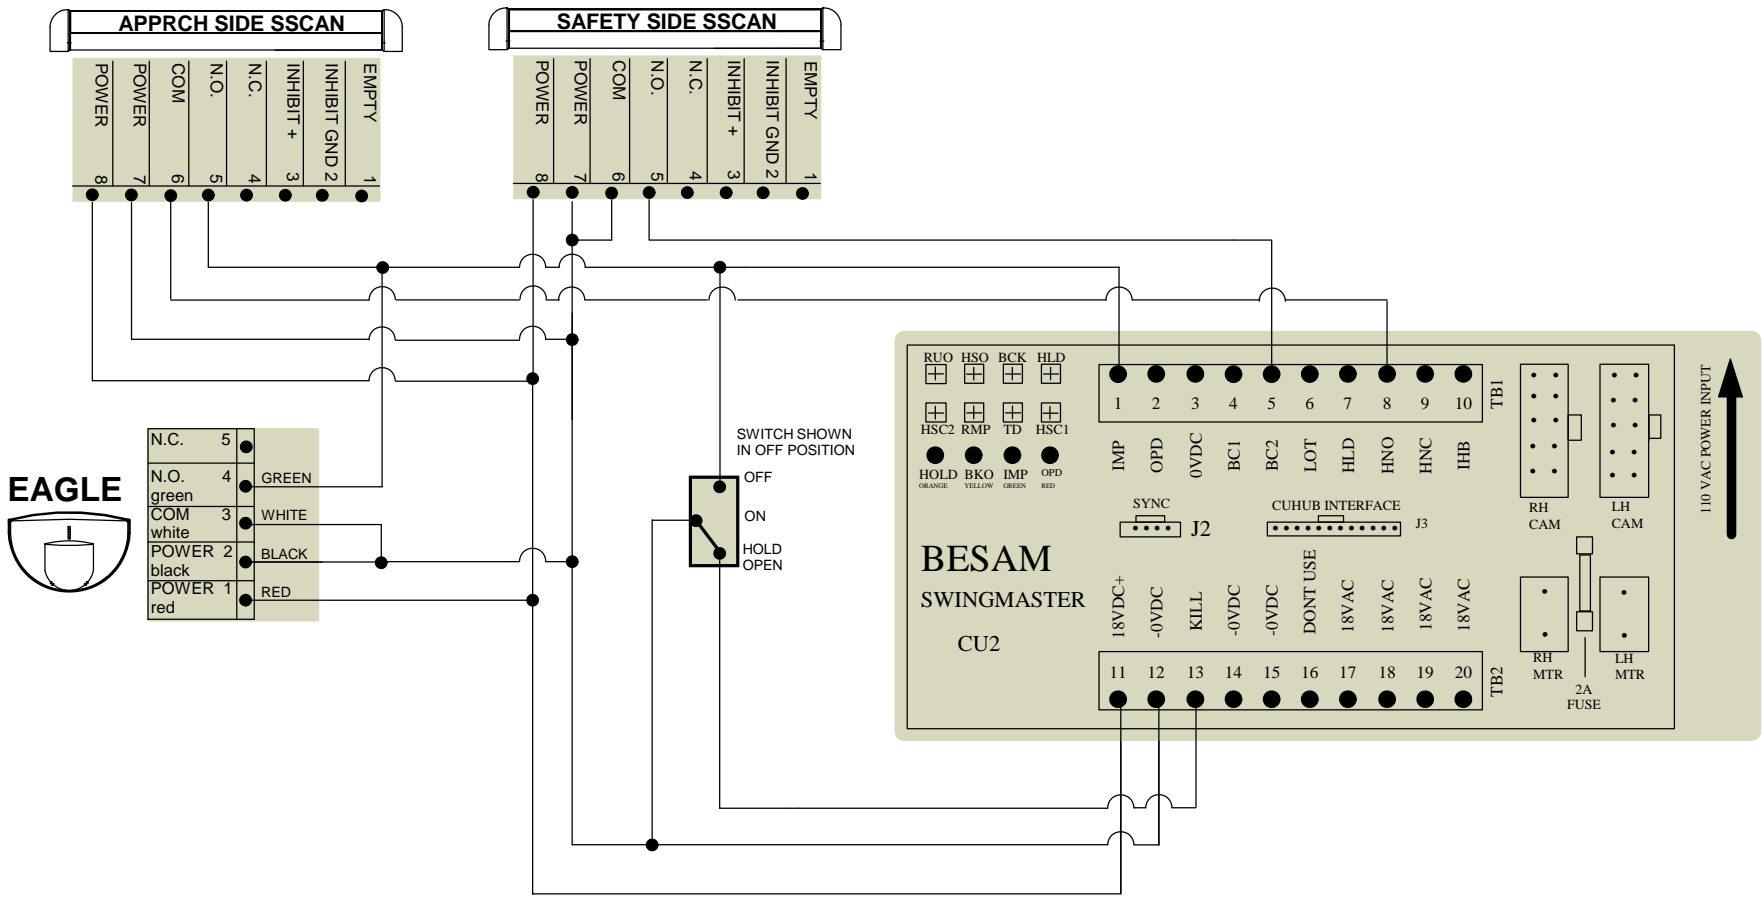
NOTE: THIS DRAWING DOES NOT COMPLY WITH ANSI 156.10 OR 156.19. BESAM AND BEA REQUEST THAT A BODY GUARD SAFETY SENSOR BE ADDED FOR COMPLIANCE. THIS DIAGRAM IS ONLY INTENDED FOR USE OUTSIDE OF THE USA.
